Software Release **WBX.4721** Details

Software Version: *WBX.4721*

Applies to Products:

- WB-200-IPCE-3
- WB-200VB-IPCE-6
- WB-400-IPCE-8
- WB-600-IPVCE-12
- WB-600CH-IPVCE-12

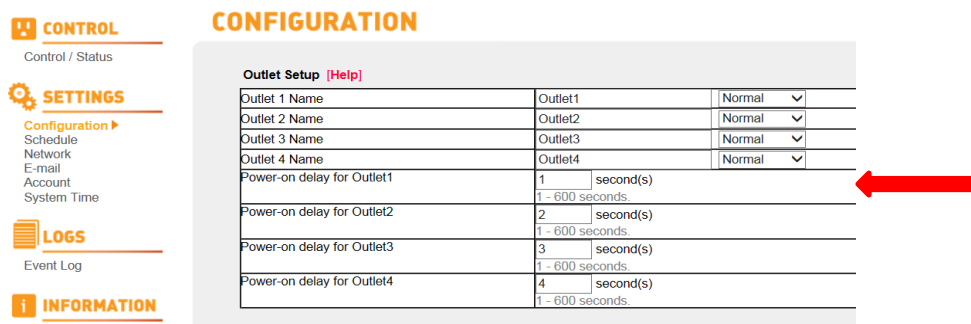
- **“Power On Delay” Time Increase**
Increased the maximum “Power On Delay” time from 120 Seconds to 600 seconds.
